AVIATION INVESTIGATION REPORT

A03C0118

ENGINE FAILURE – FORCED LANDING

WHITESHELL AIR SERVICE LTD.
de HAVILLAND DHC-3 OTTER C-GGON
LAC DU BONNET, MANITOBA 2 NME
22 MAY 2003

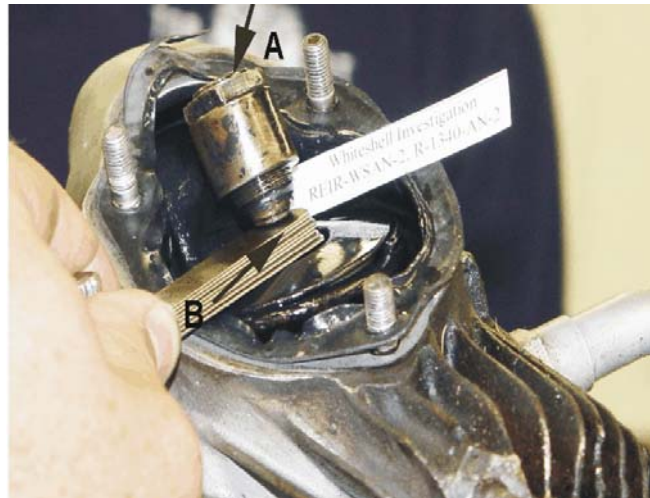
An examination of the airframe did not reveal any pre-impact anomalies. The engine, a Pratt & Whitney Wasp R-1340-S3H1-G, was removed from the accident site and taken to a local overhaul facility for tear-down analysis. During the rotation of the crankshaft, it was noted that the No. 3 cylinder exhaust valve did not open. The valve adjustment screw assembly was observed to protrude above the lock nut by 1/16 of an inch and the valve clearance was measured at 0.233 of an inch. The engine's maintenance manual specifies a minimum protrusion of the valve adjustment screw of 1/8 of an inch and a valve clearance of 0.035 of an inch (Figure 1).

Figure 1. A - Insufficient protrusion of adjustment screw

B - Excessive valve clearance

During normal engine operation, the repetitive lifting action of the valve would have further bent the spacer, effectively shortening the overall length of the push rod and increasing the clearance between the valve and the valve rocker. This increased clearance would have resulted in a pounding action of the cam roller against the cam ring lobes. An adjustment of the valve clearance during the inspection conducted at 100 hours time in service would likely have brought the clearances back into tolerance; however, the cam roller and cam ring had already been damaged. Small fragments of cam roller material would have begun to break off, creating a flat spot on the roller. As the roller stopped turning and began to slide over the cam lobes, an increased wear pattern developed. At some point, the valve was again adjusted, accounting for the valve screw protrusion being out of limits. The adjustment was likely made in an attempt to bring the ever-diminishing valve clearance back into tolerance. The wear eventually progressed to the point where the exhaust valve was not opening. The failure of the exhaust valve to open would have resulted in the exhaust gases accumulating in the combustion chamber and migrating back through the opening of the intake valve into the induction system. The hot exhaust gases would have ignited the fuel/air mixture in the induction, resulting in a backfire and the loss of engine power.

It could not be determined when the No.3 exhaust valve was last adjusted or when the valve adjustment screw protrusion was set beyond limits. The company did not check the valve clearances on a progressive 400-hour schedule, as required by the maintenance manual and could not account for the valve adjustment screw protrusion being set beyond limits. Had the out-of-limits screw protrusion been noted during the adjustment of the valve or during a regularly scheduled inspection, an examination might have revealed the excessive wear in the valve train and prevented the engine power loss.

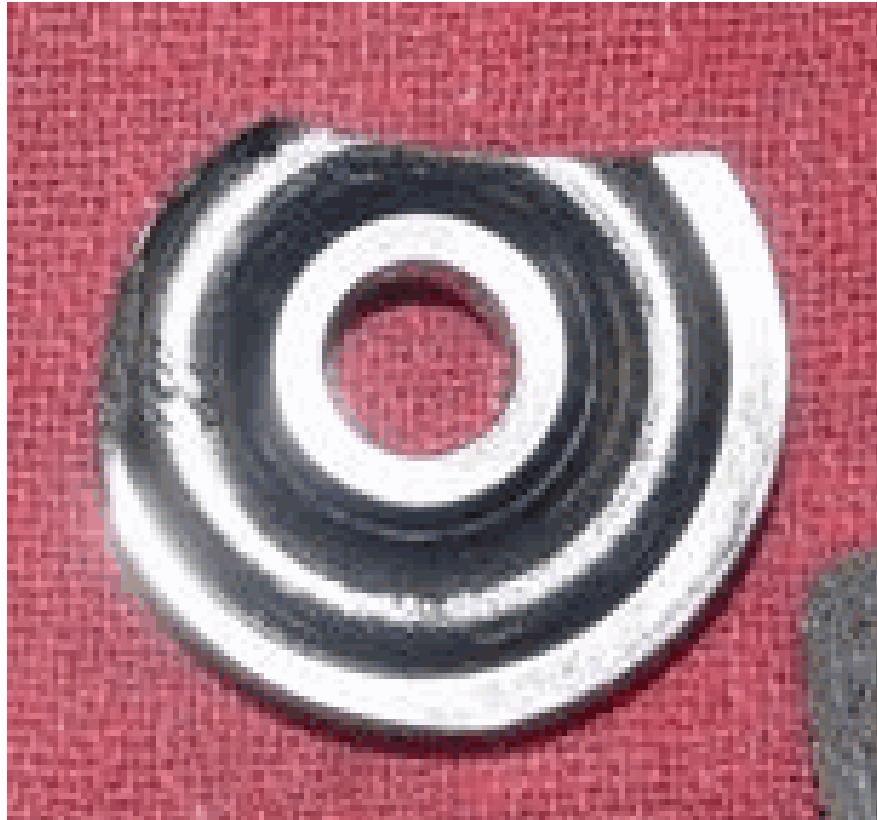
Appendix A – Worn Cam Roller

The front engine case was removed and the No. 3 cylinder exhaust roller was found to be excessively worn. The top portion of the cam roller slot tappet guide had split off and broken. The cam roller was measured and found to be worn 0.249 of an inch with a flat spot on one side (Appendix A). The cam ring was inspected and all four exhaust lobes were found to be excessively worn and out of limits. The No. 3 cylinder exhaust valve push rod was inspected and the ball ends were removed to check for the number of adjustment spacers under the ends. Push rods can be lengthened or shortened by adding spacers underneath the ball ends to accommodate valve adjustments during overhaul or cylinder replacement. Two spacers were noted under one end with one spacer found on the opposite end. The single spacer, however, had been installed standing on end and had been forcibly folded over at a right angle.

The breakage or failure of the top portion of the cam roller slot tappet guide likely occurred because the combination of wear on the No. 3 exhaust cam roller and cam lobes resulted in a longer stroke of the tappet assembly and the eventual protrusion of the cam roller pin beyond the tappet guide. This protrusion of the cam roller pin would have resulted in the cam roller pin drifting outward and splitting the top portion of the tappet guide roller slot. It is likely that the failure of the top portion of the tappet guide roller slot was the result of the engine backfire and did not contribute to the loss of engine power.
